Thermal Nondestructive Evaluation Report - Inspection of the Refurbished Manipulator Arm System in the Manipulator Development Facility of Johnson Space Center 10-12 January 2001

NASA/TM-2002-211732

July 2002

K. Elliott Cramer
NASA Langley Research Center

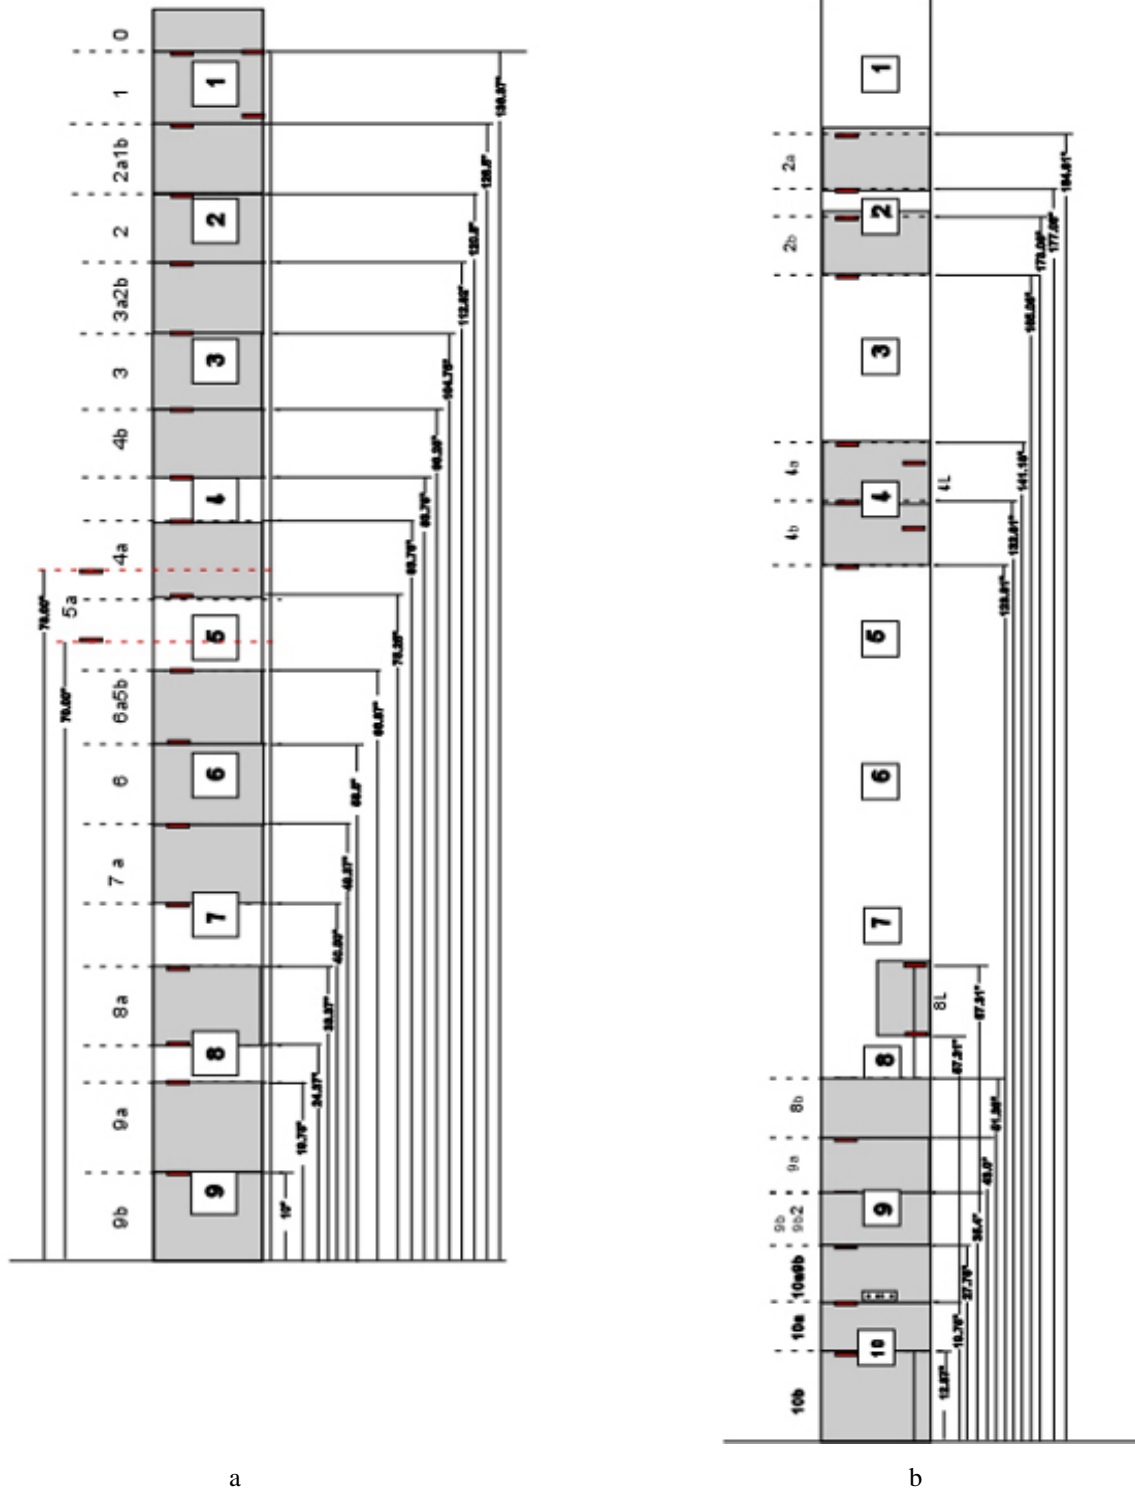
Figure 4 -- Inspection Areas on the (a) Upper and (b) Lower Arm

Figure 4 shows all of the inspection areas for both the upper and lower arm as well as the numbers for mounting pads located along the arm. Composite time derivative thermal images for Locations 1-9, as defined in Figure 5, are shown on pages 9-13 of this report. In many of the images where inspections were performed close to the mounting pads a darkening of the image occurs on either side of the pad. This darkening is the result of both the changes in heat flow in the composite and nonuniformities in the application of heat due to the presence of the pad. These areas are not as pronounced above and below the pads because of the orientation of the quartz heat lamps relative to the pads (see Figure 2).
